Inspection Site: 1 Smith St., Any town, N.Y. 10000
Inspection Date: December 16, 2010

EXTERIOR

TERMITE INSPECTION REPORT

SUMMARY

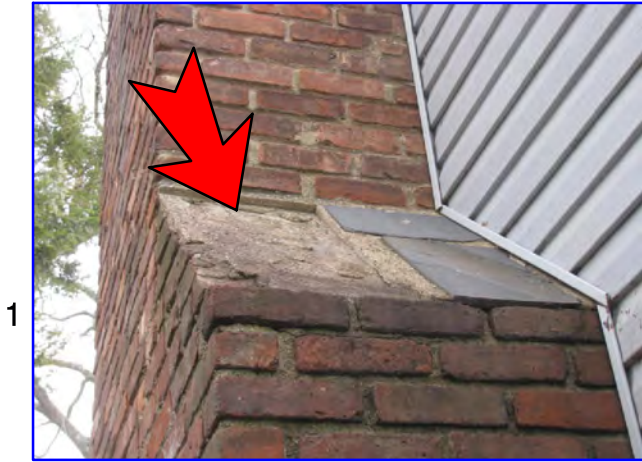
6. Railings	None Present	Install handrails on all stoops and stairs where none presently exist for safety.
7. Chimney	Brick	Loose bricks, several cracks, missing slate shelf and evidence of water penetration observed. See Photo 1. Contact a licensed and qualified mason to review/repair/replace as needed. Clean chimney and fireplace upon occupancy, and on an annual basis thereafter. <i>The chimney flue liner was not visible for inspection and should be checked for defect when cleaned.</i>

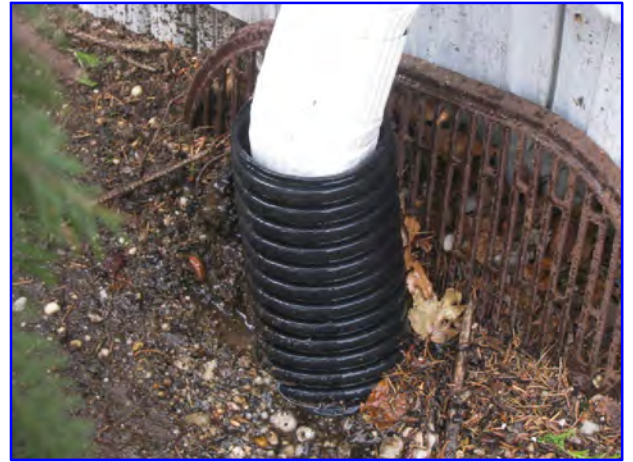
9. Flashing	Copper	Periodic inspection of all flashed areas is advisable as a preventative maintenance.
10. Gutters/Leaders	Aluminum	Clean gutters upon occupancy. Buried downspouts appear to be clogged. Direct downspouts away from dwelling. See Photo 2. Proper management of gutter/leader system is important for preventing soil erosion and possible damage to foundation/structure as well as for helping to keep the basement/crawl area dry. At least twice a year gutters, leaders, and downspouts should be cleaned and checked for proper alignment and connection. As part of normal home ownership, check system during rain for leaks and proper drainage.

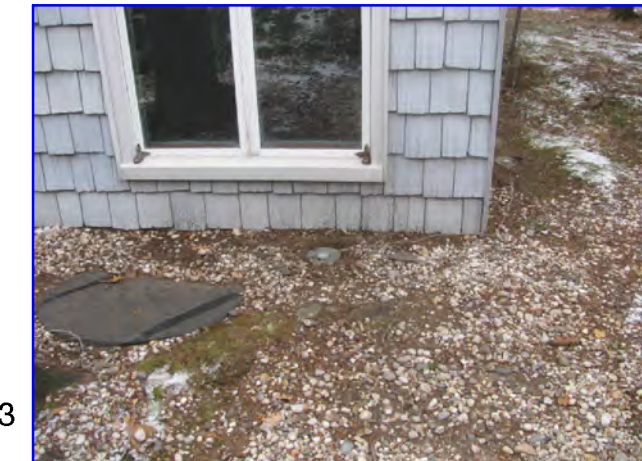
ITEM	MATERIAL	RECOMMENDATIONS
12. Siding	Vinyl	Portions of exterior siding in direct contact with the ground provide easy access for moisture and insect penetration. Contact a contractor to trim siding and provide a minimum of eight inches of clearance between the lowest portion of siding and ground. See Photo 3.

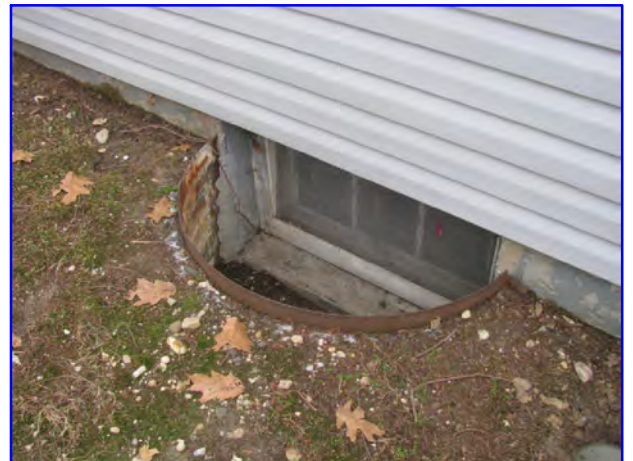
19. Side Stoop	Concrete	Serviceable. Showing signs of normal wear and tear. Able to perform intended function.
20. Window Wells	Steel	In order to help prevent basement water entry, install window well covers on existing window wells to help prevent water seepage and the accumulation of debris. See Photo 4.

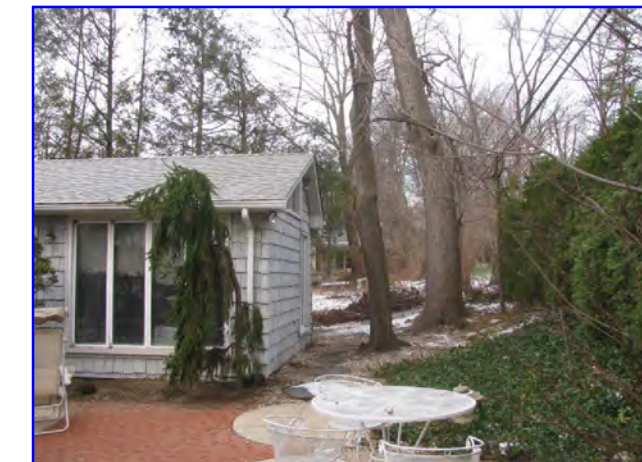
23. Deck	N/A	Not Applicable
24. Grading	Slope	Some of the property is pitched toward, rather than away from the house, this may be contributing to a water-entry problem in the basement. Keep soil pitched away from foundation to aid in positive drainage. Soil should be pitched at a minimum of 15 degrees away to help prevent seepage into basement. See Photo 5.

ITEM	MATERIAL	RECOMMENDATIONS
25. Landscape	Shrubs/Trees	Trim shrubs and trees away from house as a preventative maintenance. Two trees at the rear left corner of the dwelling are too close to the house, and may damage roof, siding, or foundation slab. Removal is advised. See Photo 5.

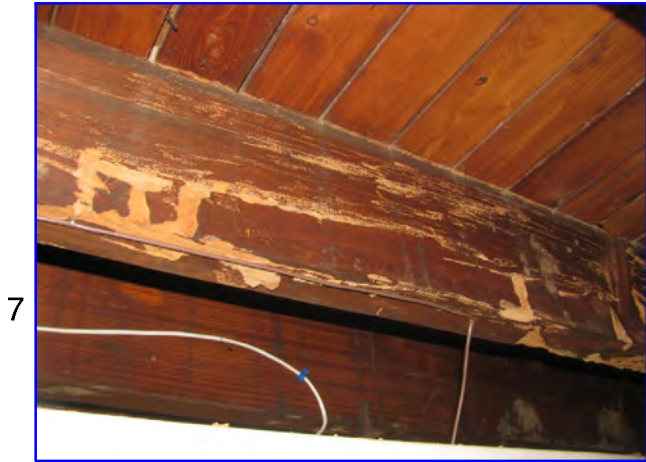
Wide spread termite damage was apparent in the basement at time of inspection. Front and rear sills and a significant amount of framing (beams, floor joists) has sustained damage. Hidden damage most likely exists as well. Since a previous treatment has been done, transfer guarantee from present owner. Significant repairs, which may be costly, are needed. If reinfestation occurs, treatment of affected areas only should be performed (within existing guarantee). If none exists, exterminate as per chemical manufacturer's recommendations and in accordance with guidelines set forth by the "D.E.C." Department of Environmental Conservation and the "E.P.A." Environmental Protection Agency. Test borings should be made on all structural members and framing to check for latent damage. Institute repairs as necessary. Annual termite inspections are recommended as a preventative maintenance measure. We cannot represent the absence or presence of termites and other wood destroying insects or resulting damage within closed walls or sealed floors.

ITEMS	DESCRIPTION	RECOMMENDATIONS
33. Termites	Evidence	<p>Wide spread termite damage was apparent in the basement at time of inspection. Front and rear sills and a significant amount of framing (beams, floor joists) has sustained damage. (photo 7 is an example) Hidden damage most likely exists as well. Since a previous treatment has been done, transfer guarantee from present owner. Significant repairs, which may be costly, are needed. If reinfestation occurs, treatment of affected areas only should be performed (within existing guarantee). If none exists, exterminate as per chemical manufacturer's recommendations and in accordance with guidelines set forth by the "D.E.C." Department of Environmental Conservation and the "E.P.A." Environmental Protection Agency. Test borings should be made on all structural members and framing to check for latent damage. Institute repairs as necessary. Annual termite inspections are recommended as a preventative maintenance measure. We cannot represent the absence or presence of termites and other wood destroying insects or resulting damage within closed walls or sealed floors.</p>

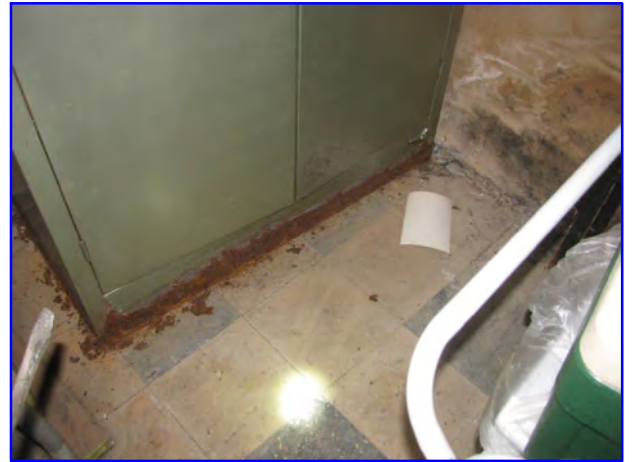
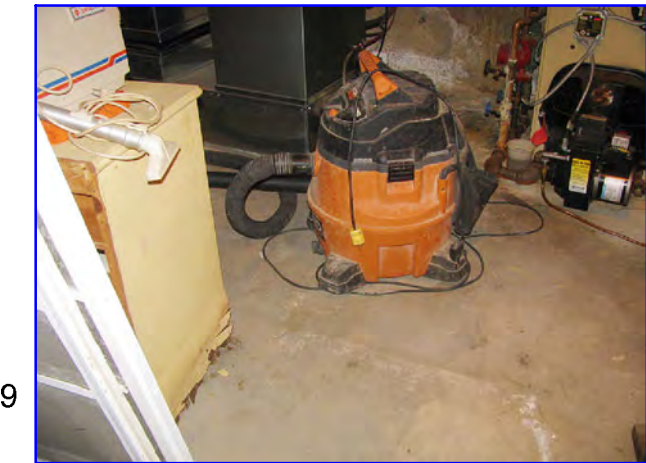
34. Dry Rot	N/A	Not Applicable
35. Water Entry	Evidence	<p>There is evidence of ongoing water entry into the basement area. Follow recommendations 10, 20, 24 to control water around foundation. Seal foundation walls and penetrations with a waterproofing compound. If condition persists, contact a qualified waterproofing company. The eventual installation of a sump pump and drain system may be required. See Photo 3 8 and 9.</p>

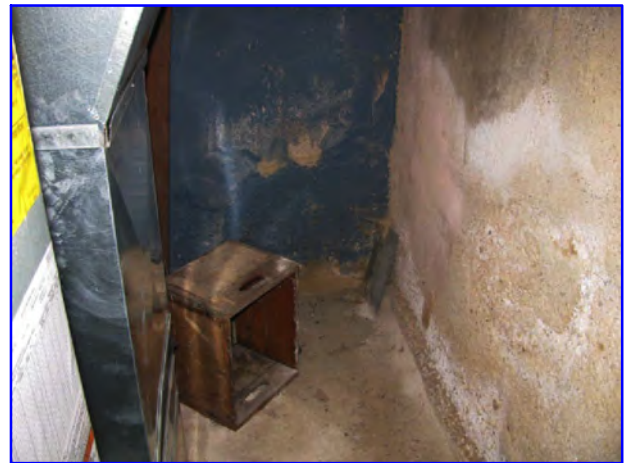
36. Foundation	Concrete	<p>Sections of the foundation walls are crumbling/peeling. Contact a waterproofing/foundation specialist for repair. See Photo 10.</p>

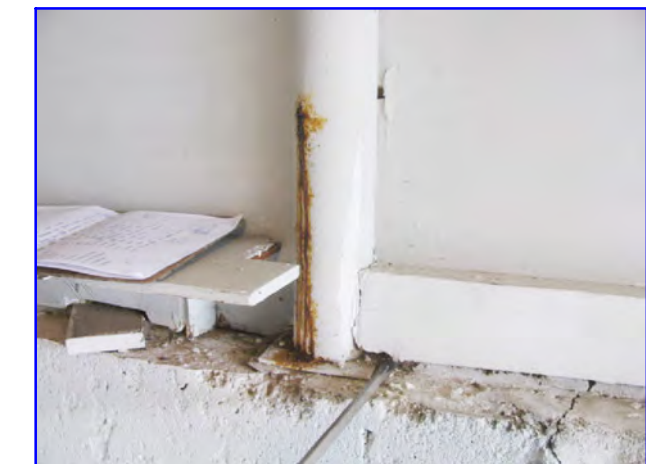
38. Columns	Steel/Wood	<p>A steel support column has split. This is considered a structural failure-column requires replacement. See Photo 11.</p>
38A. Miscellaneous	N/A	Not Applicable

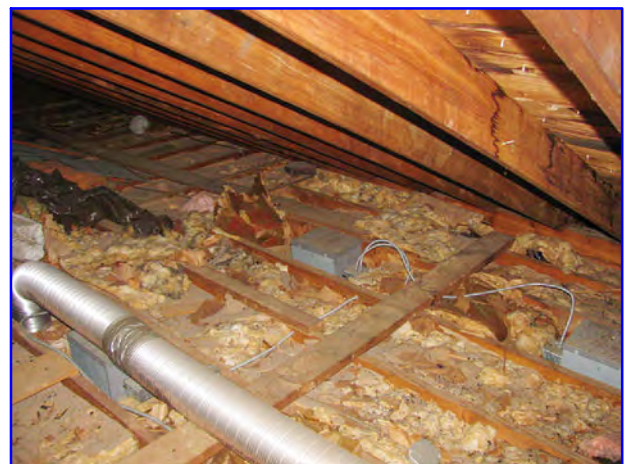
ITEMS	DESCRIPTION	RECOMMENDATIONS
39. Insulation	Fiberglass	The replacement of inadequate attic insulation with unfaced fiberglass insulation of an R19 or better value, is recommended. See Photo 12.
40. Floor	Not Present	Install plywood floor in attic area for safety and light storage.
41. Ventilation	Roof/Fan	Adjust attic fan and install a humidistat for year round use.
42. Water Leaks	No Evidence	See comment 8.
43. Access	Hatch	Insulate hatch cover with rigid type insulation to retard heat loss; and weather-strip.
43A. Electric Light	Not Present	Install adequate lighting in attic area for safety and convenience.
43B. Storage	N/A	Not Applicable
43C. Misc.	N/A	Not Applicable

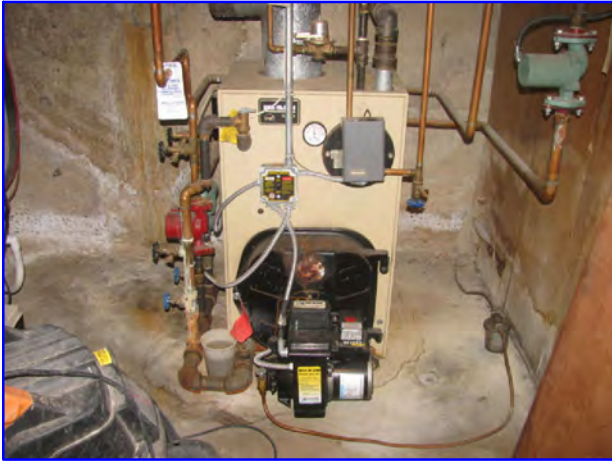
13

ITEMS	DESCRIPTION	RECOMMENDATIONS
54 Heating System	Weil Mclain Hot Water/Hot Air Hybrid- 3 Zones	The heating system was operational at time of inspection. See Photo 13. This is a hybrid system which converts hot water from the boiler into forced hot air using the HVAC air handler. A pipe appears to be leaking, contact a plumber for repair. See Photo 14. <i>It is recommended to place all heating/cooling equipment under a service contract to receive regularly scheduled maintenance. Have the contract take effect a day or so before closing and arrange to have a heating/cooling technician present during a final walk-through to inspect and service equipment. Be sure to have an understanding as to which equipment and services will be covered under the contract.</i>
55 Burner	Oil	Seepage present on underside of tank. Replace tank to prevent future leakage. See Photo 15.
56 Humidifier	N/A	Not Applicable

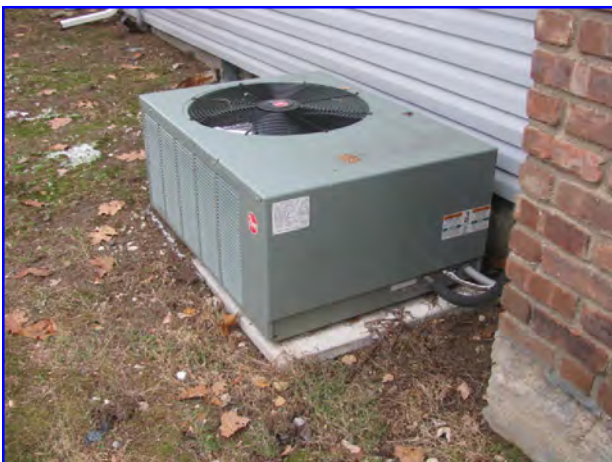
17

ITEMS	DESCRIPTION	RECOMMENDATIONS
61 Electric Wiring	Copper/BX /Romex Circuit Breakers	Install GFI (Ground Fault Interrupt) circuits in kitchen, bathroom, laundry, garage and exterior locations for safety. Test all GFI outlets on a monthly basis, replace any which fail. Replace all two wire outlets with three wire grounded outlets for added safety. The installation of a proper ground wire may be required.
62 Central Air	Rheem 2.5 Ton 1 Zone	Visibly satisfactory. Outside temperature was not warm enough (65 degrees, minimum) to check the operation of the air conditioning equipment, without risking damage to the equipment. Obtain representation of operation from present owner and have system checked prior to closing. See Photo 17.

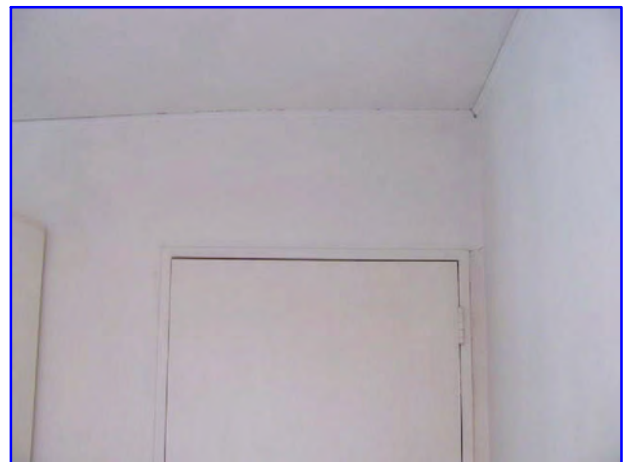
18

71. Front Corner Bedroom	Floor sagging toward common bedroom wall. Doorframe is not plumb with wall. See Photo 18. May indicated hidden structural damage. Contact a licensed and qualified general contractor to review/repair/replace as needed.
